US7-VALIDATION OF MATERIAL MODELS: NON-DESTRUCTIVE TESTING THROUGHOUT THE DEVELOPMENT OF A CARBON-FIBER COMPOSITE AUTOMOTIVE CRASH STRUCTURE

*Cameron J. Dasch
Highwood Technology LLC*

*Martin H. Jones
Ford Motor Company*

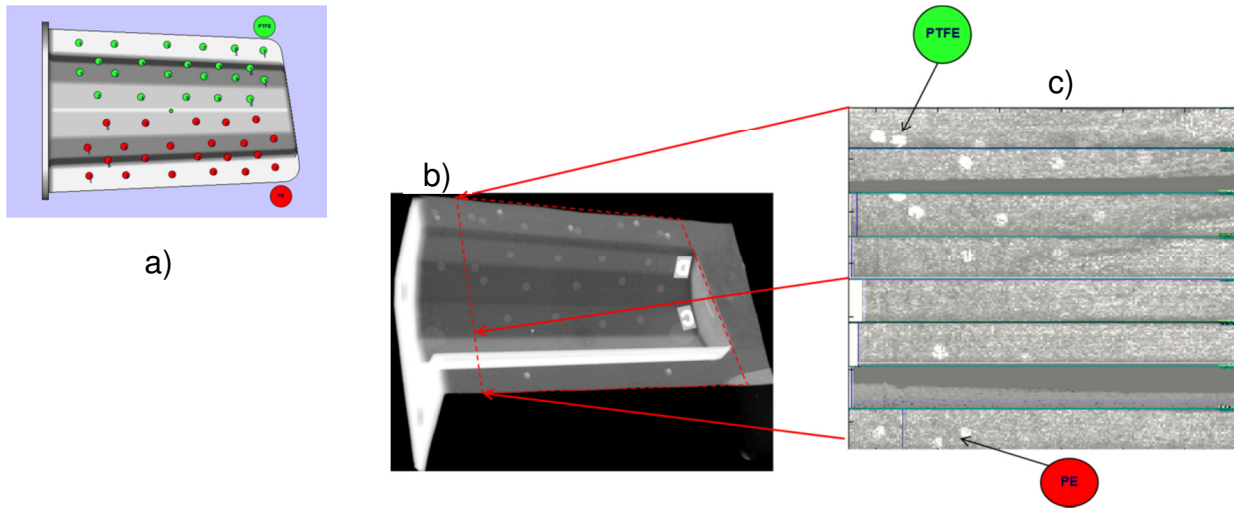
From the earlier compression-after-impact tests³, it was determined that discrepancies 6-mm in size or smaller would have negligible effect on the strength of the woven CRFP composite. Both PE and PTFE inserts were fabricated into a CC and a FB. Several inserts were placed on each layer as the plies were stacked. Figures 3 and 4 show the intended locations of the inserts as well as the radiographic and ultrasonic images obtained. The positioning of the inserts was not very accurate. In the crush cans, radiography was able to detect the PTFE inserts which had a significantly higher density. However, as seen in the earlier round work the PE inserts cannot be discerned, even at x-ray energies as low as 20 keV. In the bumpers, only a few of the PTFE inserts can be seen when they lie away from the ribs.

Ultrasonic pulse/echo can detect most of the PTFE inserts and the shallower PE inserts. The discrimination with the phased array had reduced performance compared to single-element transducers of comparable aperture. These C-scans are raw peak internal echoes without time-

distance amplitude corrections which would improve the detection. The ultrasonic performance on the front bumpers was similar.

Figure 3. Detection sensitivity on a crush-can half-section using thin PE and PTFE inserts. a) Schematic of insert locations, b) low-energy radiograph showing PTFE inserts, and c) high-frequency ultrasonic C-scan of PE and PTFE inserts.

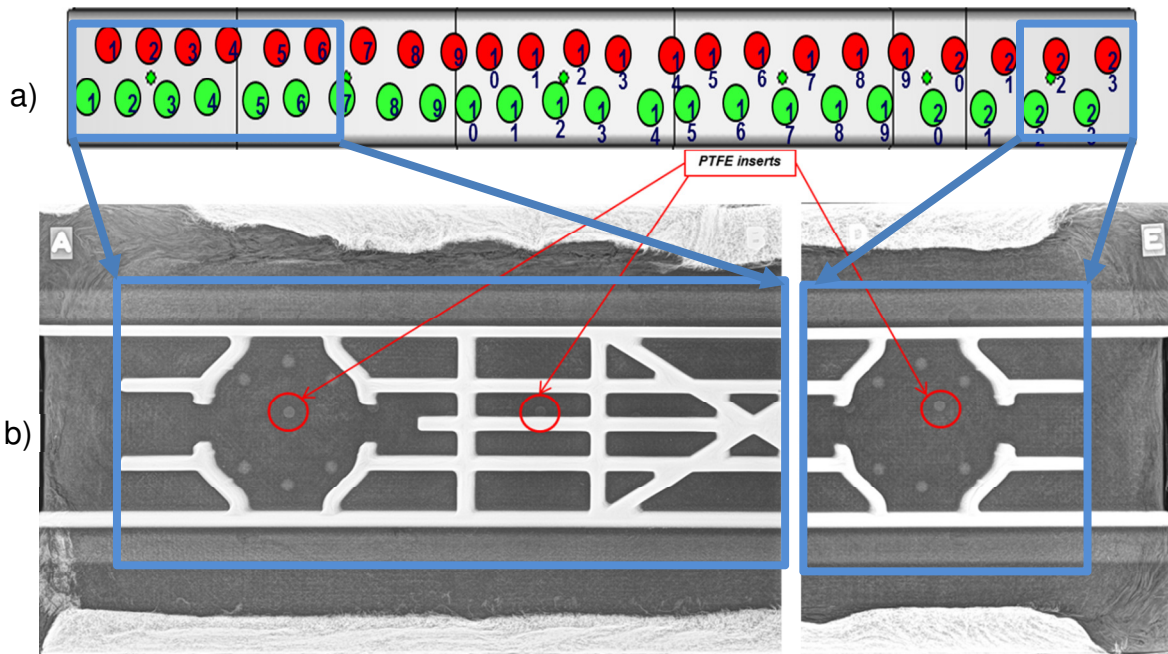
Figure 4. Detection sensitivity on a front bumper using thin PE and PTFE inserts. a) Schematic of insert locations and b) low-energy radiograph showing PTFE inserts.

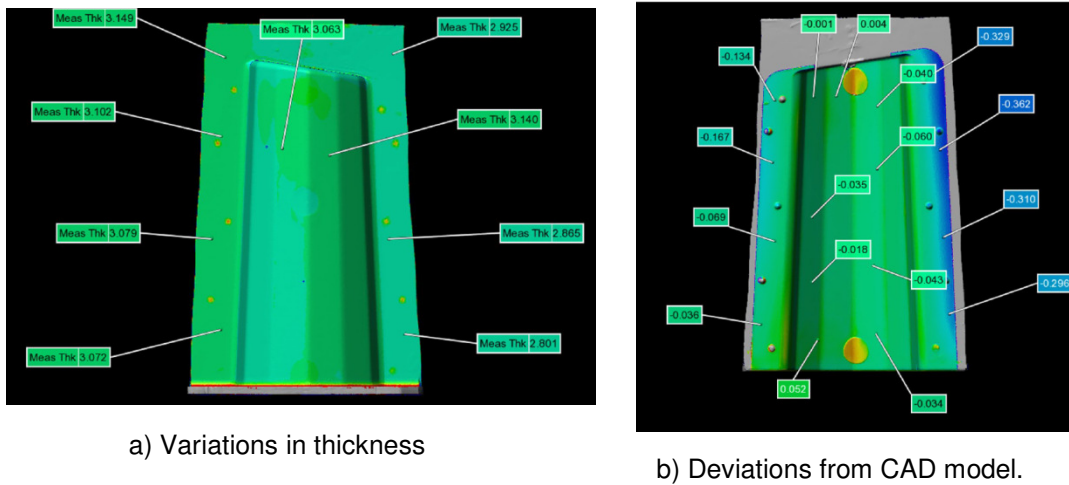
The results of inspecting the crush can halves are shown in Figures 5-8. The optical surface scans provide maps of both the thickness and deviations from the CAD model (Fig 5). The surfaces were typically within 0.1-mm of the thickness specification and the surfaces were on average within 0.3-mm of the CAD surface. Some parts such as shown in Fig. 5 show a small amount of part distortion at a maximum of 0.5-mm. This was acceptable for the assembly of the components.

Figure 5. Optical surface mapping. a) Variations in surface thickness, b) deviations of the outer surface from the CAD model.

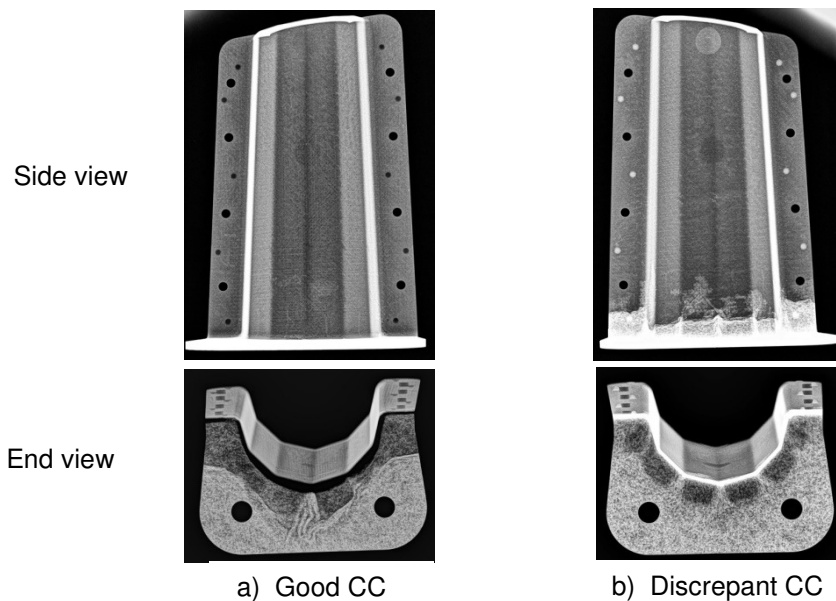
Figure 6. Low-energy radiographs (side view and end view) of crush can. The end views show the fabric tab pattern variation due to SMC flow. a) "Good" CC with low dart location and low intrusion of SMC and b) Discrepant CC with high dart location and higher intrusion of SMC.

Low energy radiographs were especially useful in this project (see Fig. 6). Typically two views were taken: a side-view of the facets and side-flanges and an end-view of the rear flange. The glass-fiber SMC in the rear flange has much higher attenuation than the fabric CFRP in the sides. The side views detected that some CC's had discrepant movement of the SMC from the rear flange up along the facets (Fig. 6b). This would tend to squeeze resin from the pre-preg. This movement also may be associated with the stretch and bunching visually and ultrasonically observed in this rear region of the crush can. The end views show how the fabric is darted in order to create tabs that extend out into the rear flange. In the discrepant CC, it appears that the fabric has moved forward so the darts are above the rear flange radius. Even in the good CC, there appears to be movement in the fabric so that the tabs are less well defined.

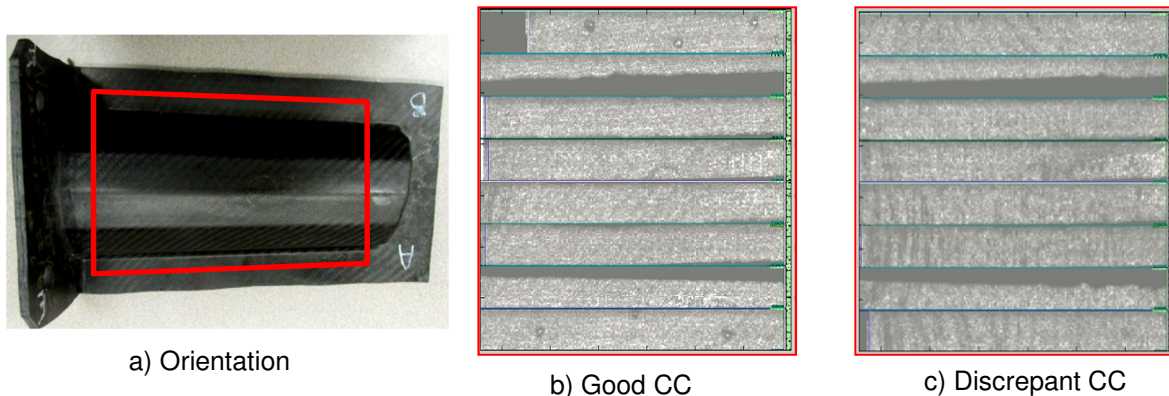
Ultrasonic pulse/echo images using the phased array did not indicate any delaminations or foreign matter (see Fig. 7). The images from the facets as well as the side flanges are combined to create an unfolded image of the fabric area. Two scans of each area were taken to assure that all features were repeatable. Due to the array fixture size and non-imaging edge of the array, roughly 20-mm of each end of the facets could not be imaged. Also, the narrower facets next to the side flanges were not completely imaged. The indents used to align the two CC-halves are visible on the side-flanges. The only significant discrepancies observed are the vertical (circumferential) striations seen in Fig. 7c closer to the rear flange. Mechanical property testing found the discrepant CC (Fig. 7c) had significantly lower strength. The striations may be associated with folding or bunching of the fabric.⁷

Figure 7. Ultrasonic pulse/echo C-scan of the CC side facets. The images from the facets and side flanges are collaged to into fold-out view. a) photo showing CC orientation, b) higher strength CC, and c) CC with reduced strength showing striations may come from fabric folding or bunching.

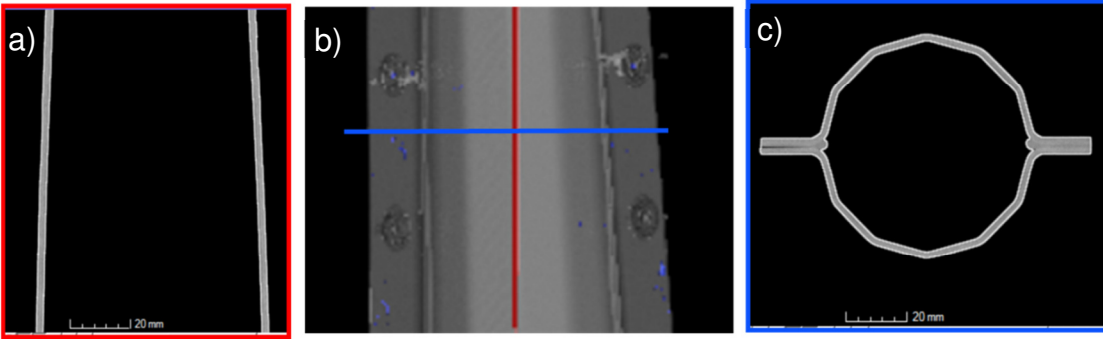
An example of the CT scans of two crush can section bonded together are shown in Fig. 8. The CT scans have a voxel size of 0.1-mm which is not adequate to resolve the individual plies of the fabric composite (Fig. 8). No porosity was observed within the fabric CFRP of the facets or side flanges. There was minor porosity in the adhesive.

Figure 8. CT inspection of bonded crush can sections. a) vertical cut, b) perspective surface view showing location of cross-sections, c) cross-cut.

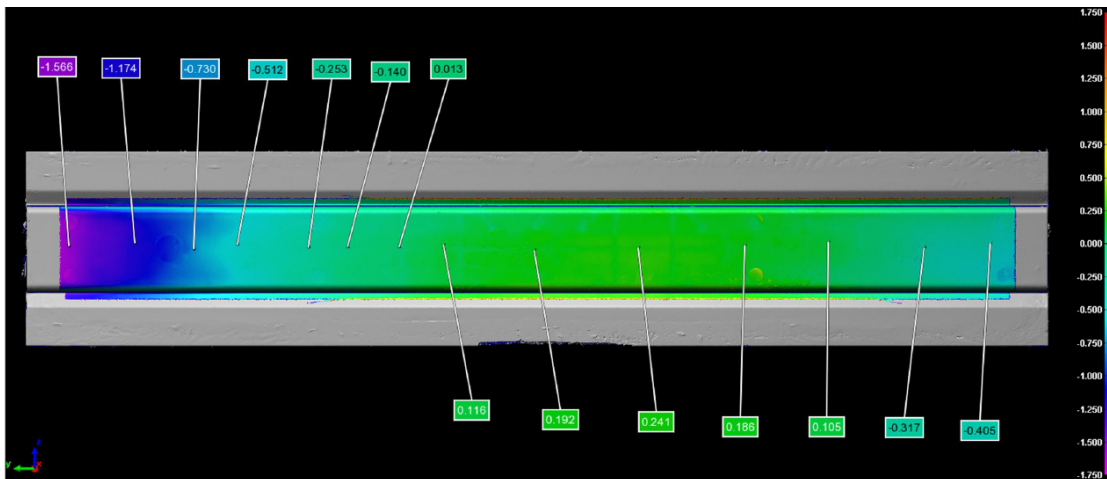
The optical scan of the front bumper also showed that the thicknesses which were within specification. The bumper does present some technical problems since it is long and thin. Multiple sectional scans of the front, back and edges must be carefully pieced together using alignment targets. A map of the deviation of the surface of an as-molded, untrimmed bumper from the CAD model is shown in Fig. 9. The gray areas are outside the trim line. The maximum deviation was 1.6-mm over the 1000-mm length of the bumper. This was deemed acceptable and presented no assembly problems.

Figure 9. Optical surface map of an untrimmed front bumper showing deviations of the front surface from the CAD model. The gray areas are outside the trim line.

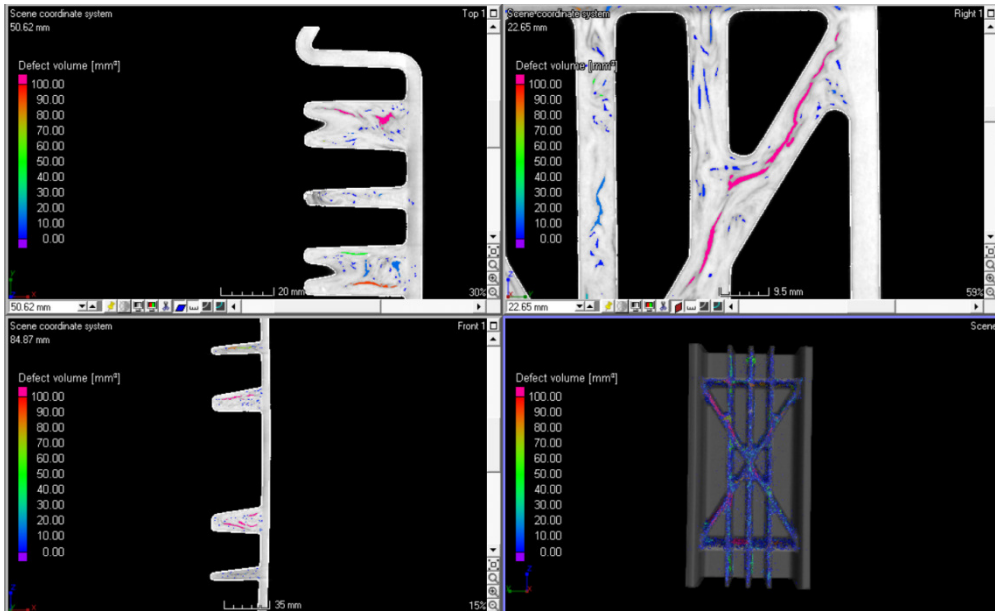
CT imaging was found to be the most useful tool for the complicated structure of the front bumper. This revealed porosity throughout the bumper ribs that are carbon-fiber SMC (See Fig. 10). Figure 10 is a superposition of the part density with a porosity analysis. The porosity surfaces are color coded to indicate the volume of each pore/crack. Sectioning of the bumper allowed a direct comparison of the CT to the polished micrograph. This is shown in the companion paper on the material processing.⁷

Figure 10. CT of FB section showing perspective view (lower right) and three orthogonal slices. These are composite images of the density (in gray) overlaid by a porosity analysis. The color of the porosity indicates the volume of the pore/crack.

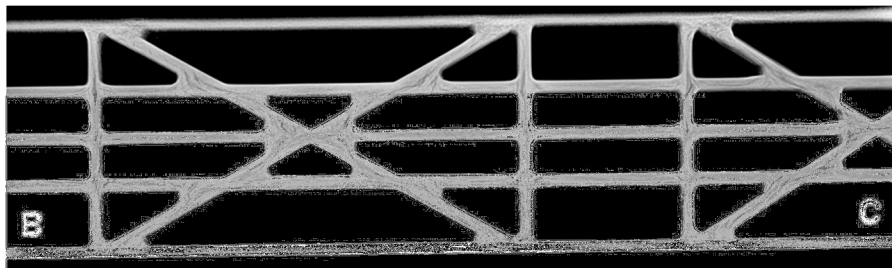
Figure 11. Low-energy radiographs of a 250-mm long section of front bumper: a) Higher energy x-rays showing porosity and cracks in the SMC ribs and b) lower energy x-rays used to inspect front fabric surface for foreign matter.

Low energy radiography was primarily intended to detect foreign matter within the FB. This application is shown in Figure 11b with lower energy x-rays (about 35 keV). At these energies small variations in the FB woven material can be observed, but the ribs are strongly attenuating. At higher energies, with less attenuation by the ribs, the porosity/cracks seen in the CT scan can also be seen (Fig. 11a). This very fast diagnostic would be a useful tool for 100% inspection of a production bumper with ribs.

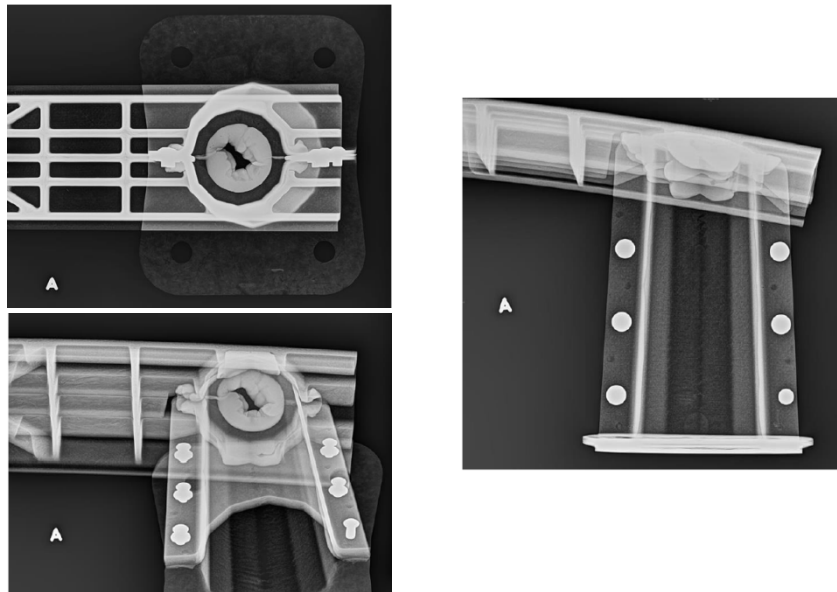
In the final assembly two CC sections are riv-bonded together into a CC sub-assembly which is then bonded into a molded socket in the front bumper. Details of the bonding are shown in Fig. 12 and 13. The entire assembly could be radiographic imaged in five sections with high contrast and resolution. The adhesive which is roughly 1-mm thick can be readily seen especially in the FB-CC interface. In the joint, an excess of adhesive is used to ensure complete coverage of the large interface. The bonding between the CC-halves is less evident because the side-flange area is completely filled. Early work showed that incomplete fill could be readily detected.³

Figure 12. Radiographs of FB-CC assembly. There are three views of the same assembly. a) end view, b) side view, and off-axis view. The spread of the adhesive between the FB and CC can be seen. The adhesive completely fills the CC side flanges.

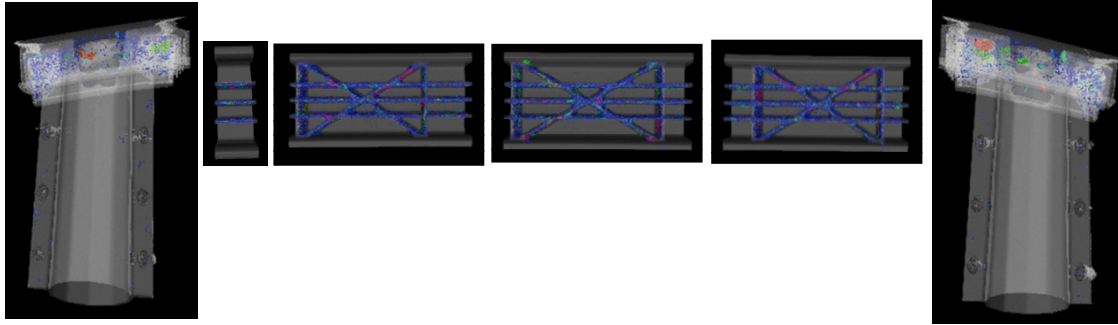
The assembly was too large to CT'ed as a single piece. It was necessary to cut the bumper into at least five pieces to fit into the medium resolution CT cabinet (See Fig. 13). All the FB sections exhibited the porosity discussed in Fig. 10. A small amount of porosity was seen in the CC side-flange joint, but most of this was associated with the alignment bumps/dimples on the surfaces or isolated air bubbles.

Figure 13. CT of FB-CC assembly. This is super position of the outer surface and a porosity analysis.
