# COMPOSITE LIFTGATE DUCTILITY PERFORMANCE

*Peter H. Foss  
Staff Researcher  
General Motors Research and Development  
Warren, MI*

## ABSTRACT

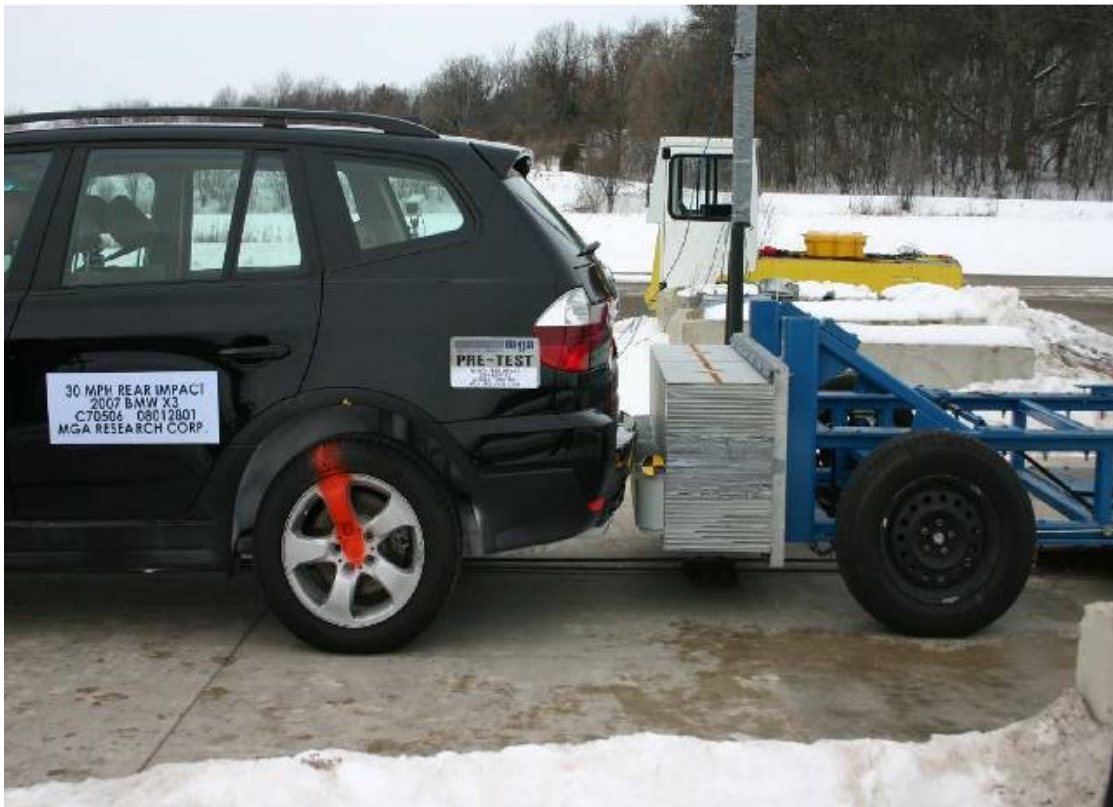
Figure 2. FMVSS 301 offset deformable barrier test configuration[2].

This impact can cause significant deformation of the rear structure of the vehicle which can result in large relative motion between rear body components. A typical pretest photo showing the sled with the aluminum honeycomb deformable barrier is shown in Figure 2[2]. Publicly available after-test photos are shown in Figures 3-4[2] and 5-6[3] for two vehicles currently available for sale in the US. These tests were performed by MGA Research Corporation in Burlington, WI for the National Highway Traffic Safety Administration (NHTSA). As shown below, relative displacements on the order of 200 mm can be observed in the lower portion of the liftgate and floor structure. Typically, the lower outboard corner of the liftgate on the unstruck side deforms very little while the striker and latch are moved forward much farther. This results in large (>200 mm) displacements in the striker and latch area relative to the rest of the liftgate.

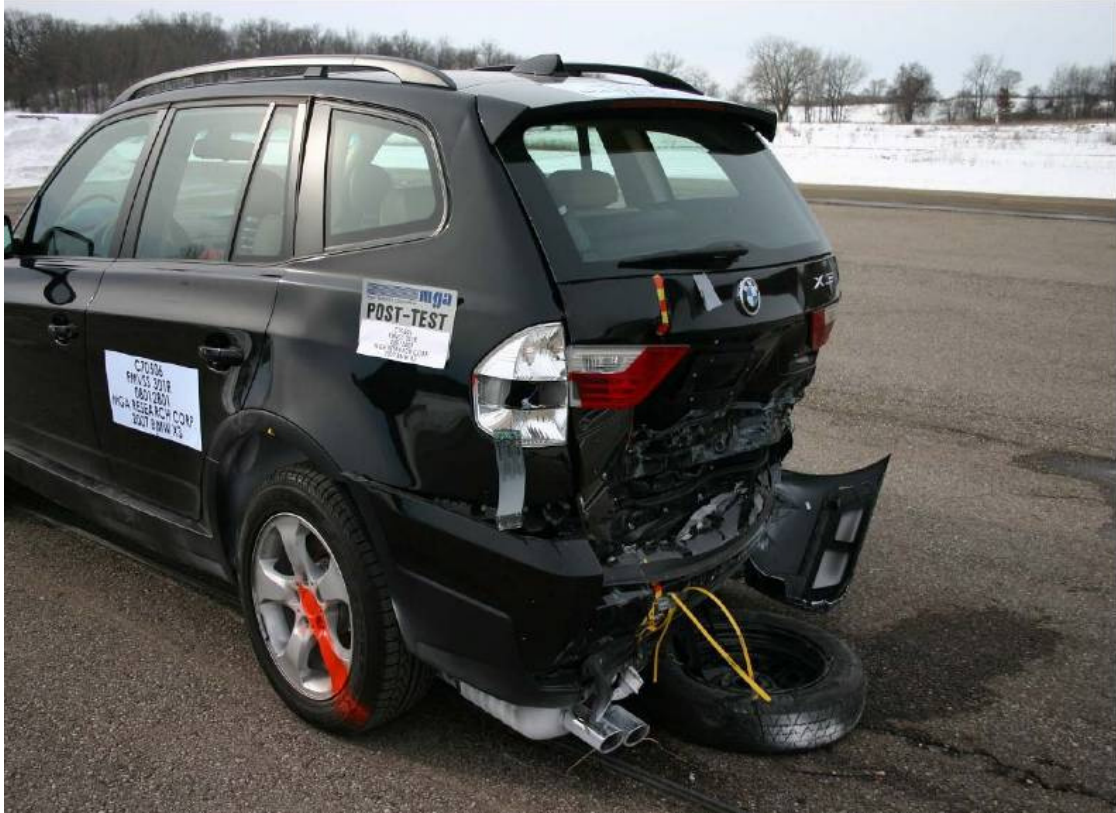
Figure 3. FMVSS 301 offset deformable barrier test results [2].

As shown in Figures 3-6, the FMVSS 301 test results in very large displacements in the rear of the vehicle. In the vicinity of the unstruck lower corner of the liftgate and the entire region above the beltline, there are usually minimal displacements. However, the situation is very different on the struck side and in the center of the vehicle. Displacements of the striker greater than 200 mm have been observed.

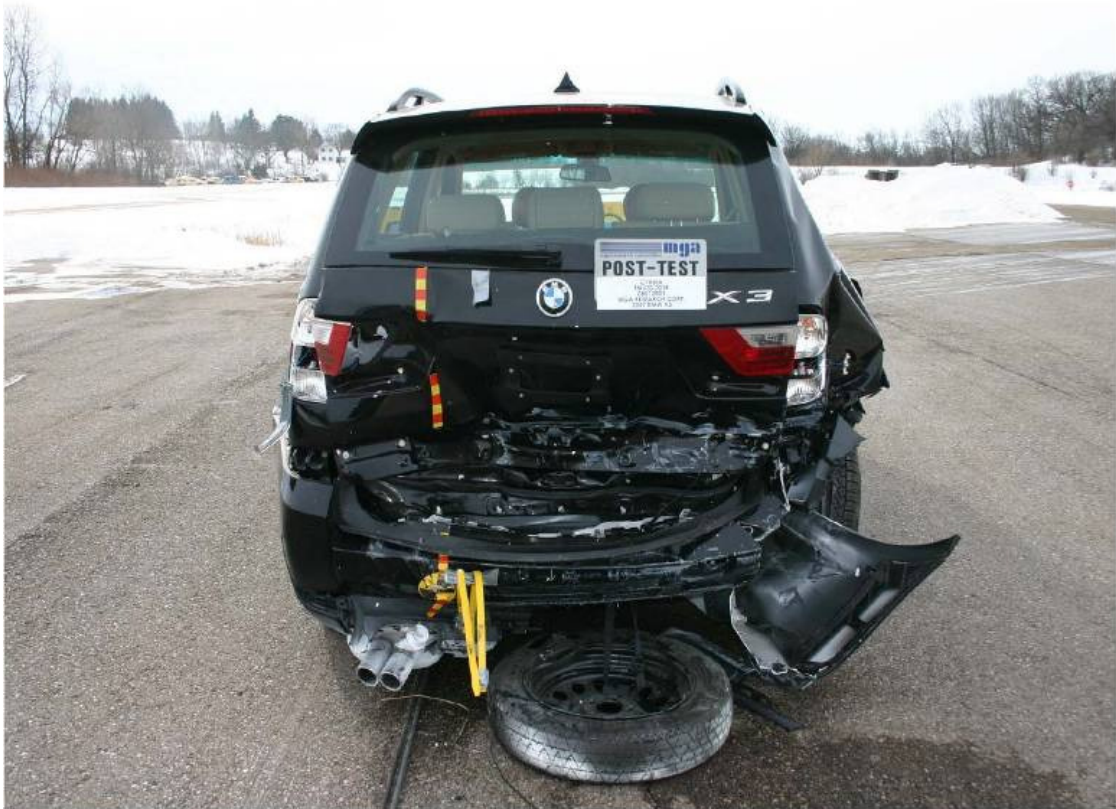
Figure 4. FMVSS 301 offset deformable barrier test results [2].

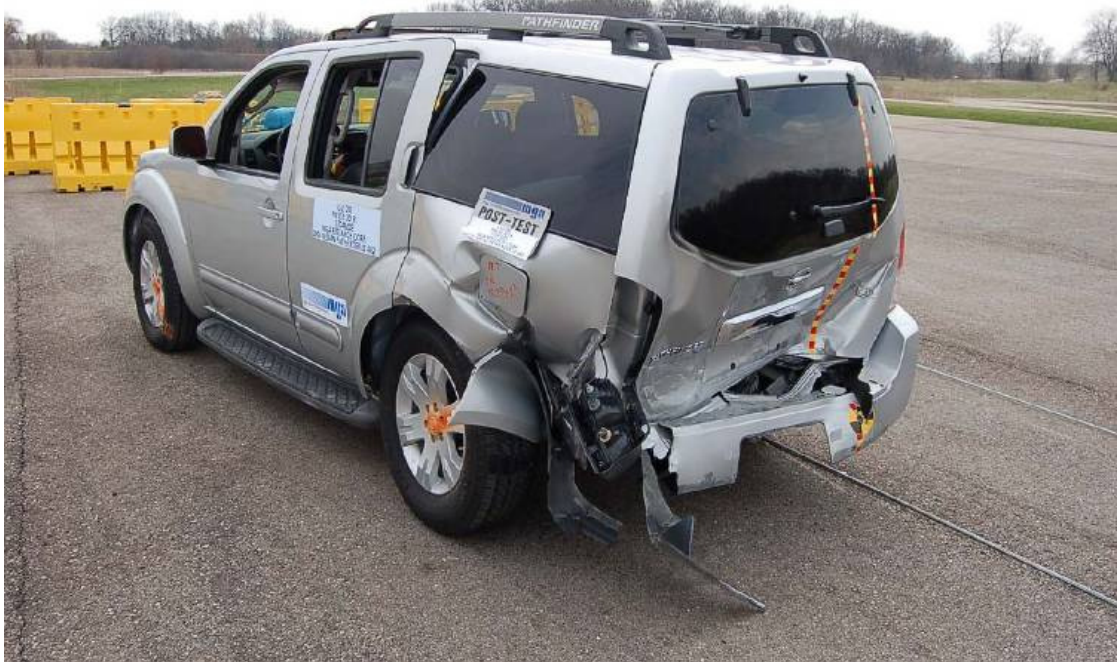
Figure 5. FMVSS 301 offset deformable barrier test results [3].

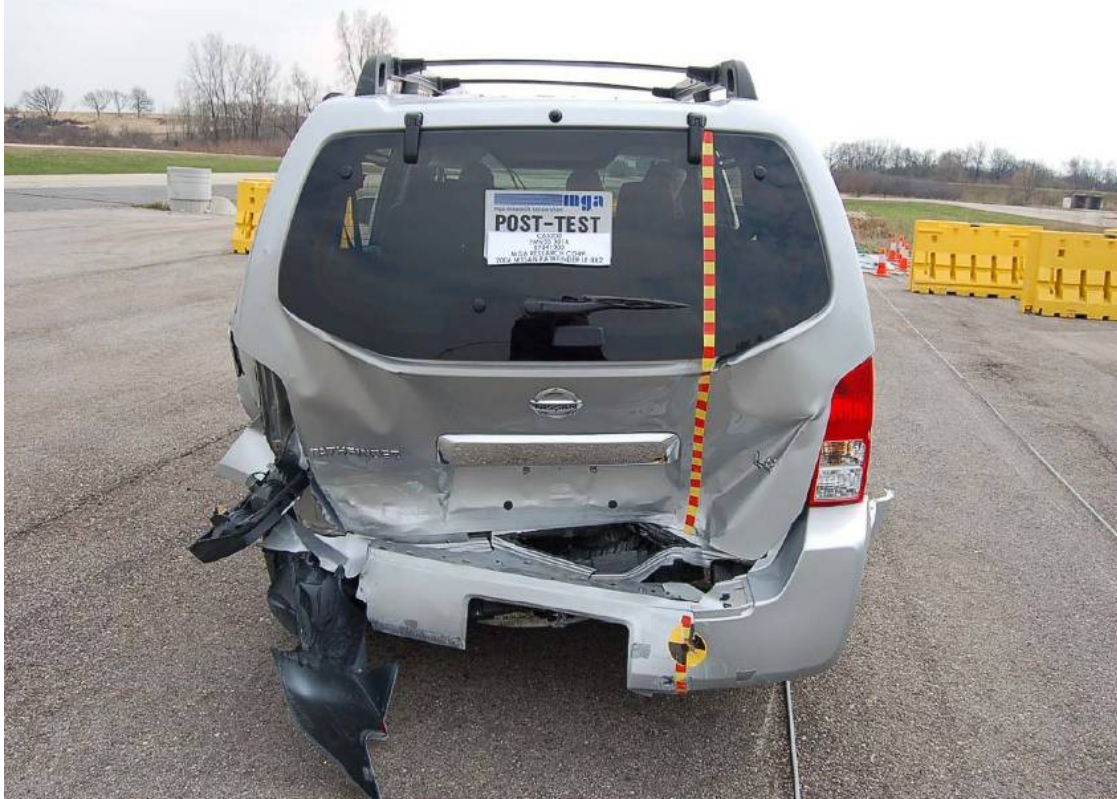
Figure 6. FMVSS 301 offset deformable barrier test results [3].

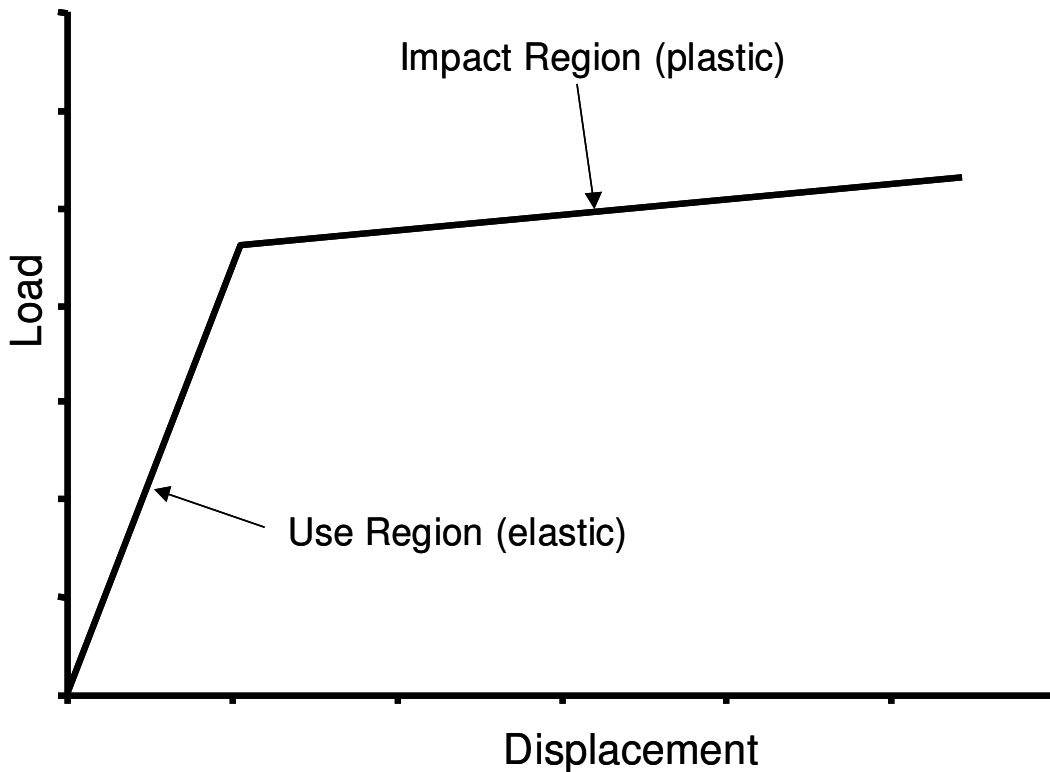
Figure 7. Desired load-displacement response of composite closures to be stiff in normal use but ductile in crash situations.

A vehicle structure is designed to be stiff at low strains in the region of normal use. To protect the occupants in crashes, system ductility becomes important to absorb the energy imposed on the structure. The load-displacement (stress-strain) response for most composite materials is essentially linear. Current research to improve the ductility of composite structures is ongoing at GM and elsewhere with a goal of reaching a load-displacement response similar to Figure 7. This type of response is usual for metallic materials with a typical elastic-plastic material response. However, for composite materials often the inherent stress-strain response is much more linear with a brittle failure.

The elastic-plastic system behavior shown in Figure 7 is an idealized response that may not be feasible or required in actual crash situations. Prototype and production composite liftgates need to be tested in rear crash tests to evaluate their performance. While the magnitude of displacements of the latch area appear to be consistent across many vehicle manufacturers and vehicle types, the load requirements are less clear. However, the forces acting on a liftgate during a crash from the inside are very difficult to estimate. While static component tests are very useful from development purposes, they must be supplemented with full vehicle crash tests.

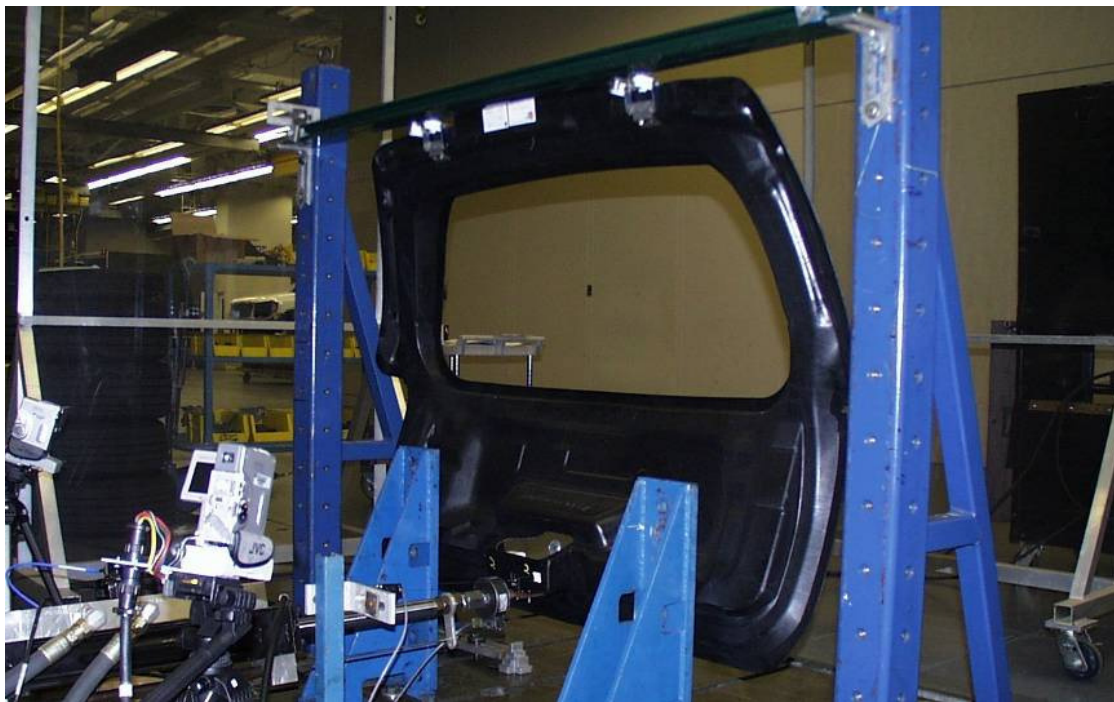
Figure 10. Experimental setup at the GM Body Test Lab for measuring the load-displacement response of a liftgate when the striker is pulled forward (in-car direction).

The test shown in Figure 10 was constructed for development purposes to simulate the dynamic deformation of the liftgate in the 301 test configuration. This testing has been performed in several different but similar setups. The liftgate sample was suspended by bolting the body side hinges to a crossbar. The liftgate was then positioned in an approximately closed position with the latchbox bottom surface parallel to the bedplate. Two stanchions were then placed against the bottom edge of the liftgate inner panel to constrain the liftgate from moving forward. A fixtured striker fully latched to the liftgate was used to apply a forward displacement to the latch. Displacements were recorded using the LVDT transducer integrated into the hydraulic actuator. Forces were measured using a load cell attached between the hydraulic ram and the striker. The actuator was stroked forward in car 250 mm of displacement, held and then returned to zero. Testing rates were quasi-static at speeds of 1-2 mm/s.

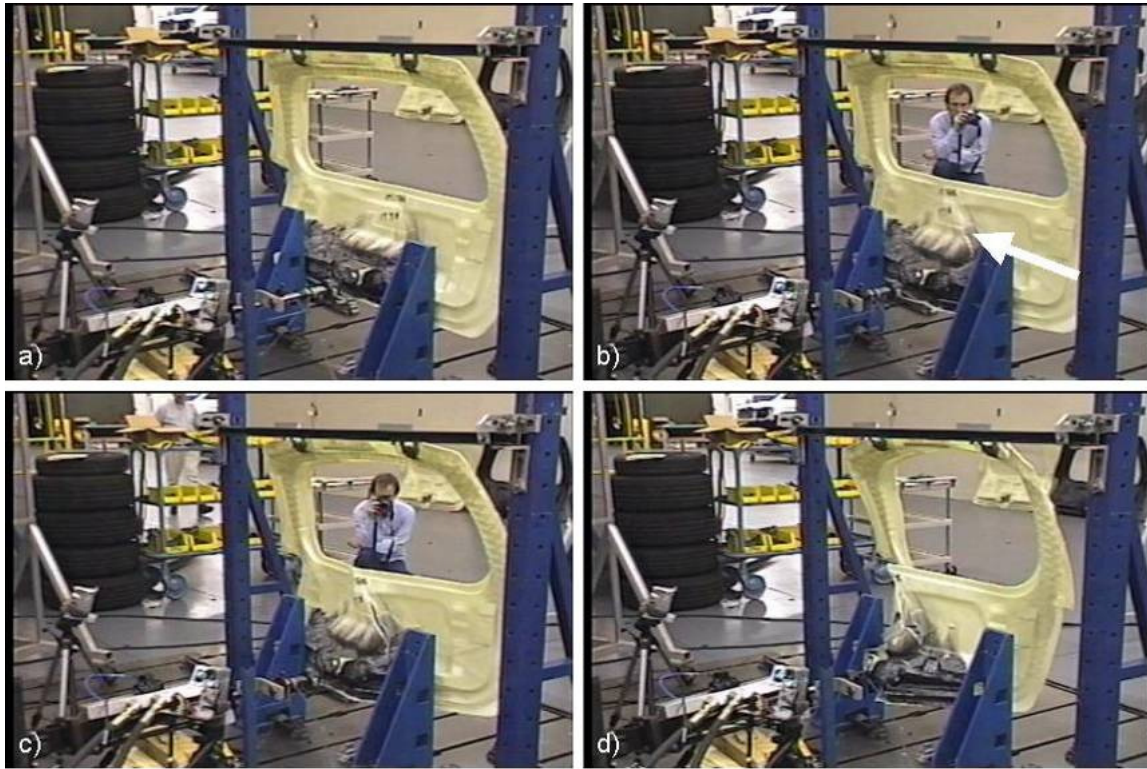
Figure 14. Twintex reinforced DLFT inner panel load displacement test showing a) initial state, b) first crack appearance, c) complete cracking of the unreinforced portion and d) maximum displacement of 270 mm.

Several pictures of the “DLFT - Twintex” panel are shown in Figure 14. View A shows the initial state while view B shows the first visible crack appearance, well away from the latch area. There was also some distortion and bending of the latchbox in the fracture location of the previous unreinforced liftgate testing. As the displacement continued to the final value of 270 mm in view D, the unreinforced portion of the panel is broken virtually in half, but the latchbox areas of the structure still supports load due to the reinforcement patch. The “GMT - GMTEX” panel is shown from various angles while at maximum displacement in Figure 15. As before, the reinforcement allows the panel to support load all the way out to maximum stroke on the actuator.

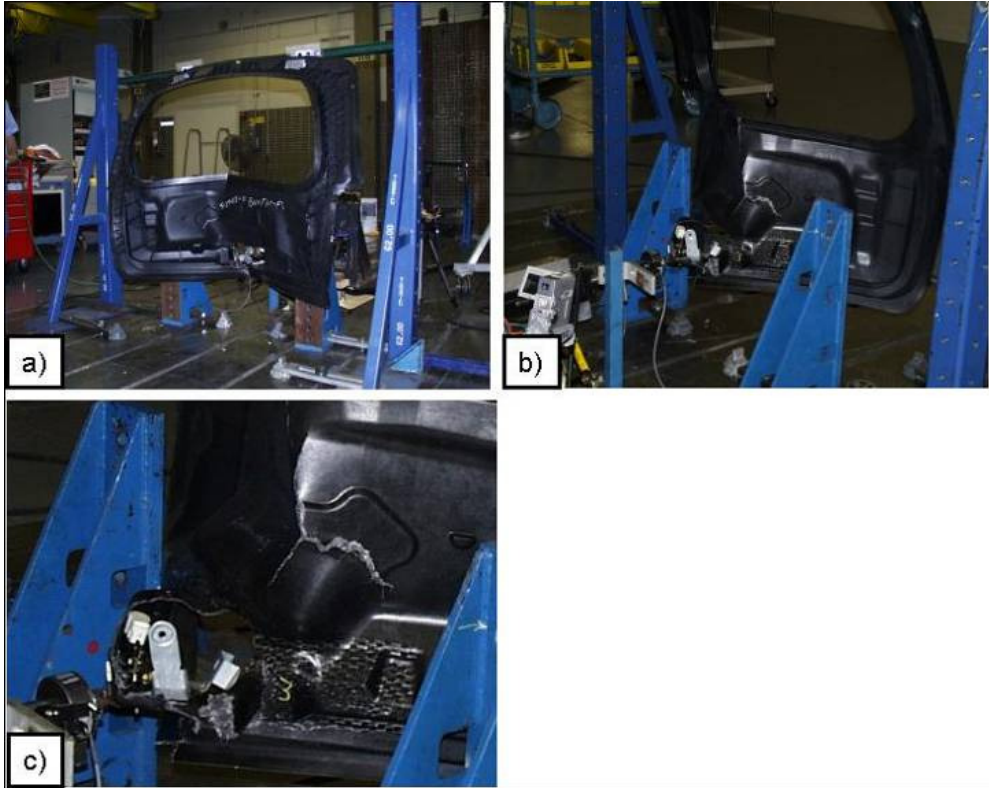
Figure 15. Various views of the GMTEX reinforced GMT inner panel while still under load at maximum displacement of 264 mm.

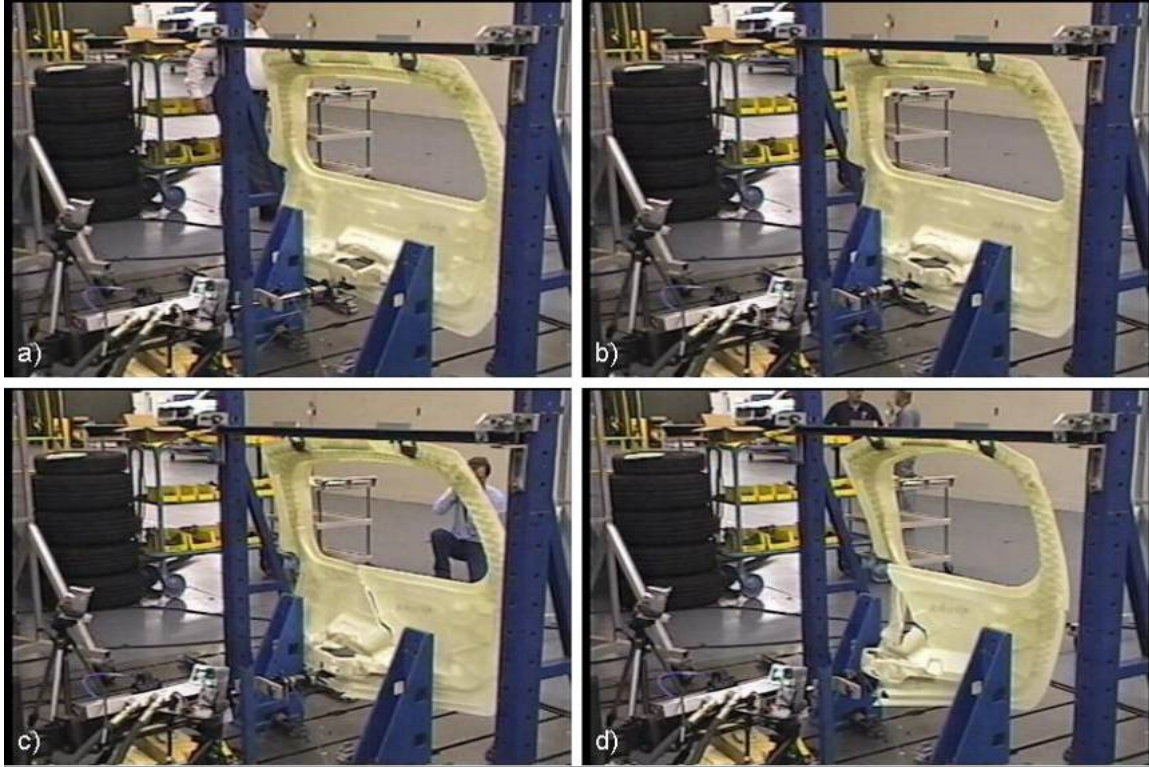
Figure 17. Hardwire reinforced DLFT inner panel load displacement test showing a) initial state, b) first crack appearance, c) complete cracking of the unreinforced portion and d) maximum displacement of 266 mm.

Results for the “DLFT - Hardwire” panel load displacement test are shown in Figure 17. While similar in many ways to the Twintex reinforced panel, the DLFT – Hardwire reinforcement was more effective in stopping propagation of the initial latchbox crack. In Figure 17b, we see a crack, similar in many ways to the start of the unreinforced liftgates brittle failure. However, the crack cannot propagate through the wire reinforcement. This allows the liftgate to continue to support load all the way out to the maximum displacement of 266 mm, even though the unreinforced portion of the panel is cracked completely in half. Close-up views of the latch area with the reinforcement are shown in Figure 18. Clearly, the latchbox begins to fracture brittly in Figure 18b. But the wire reinforcement prevents the cracks from propagating and causing latchbox separation from the panel.

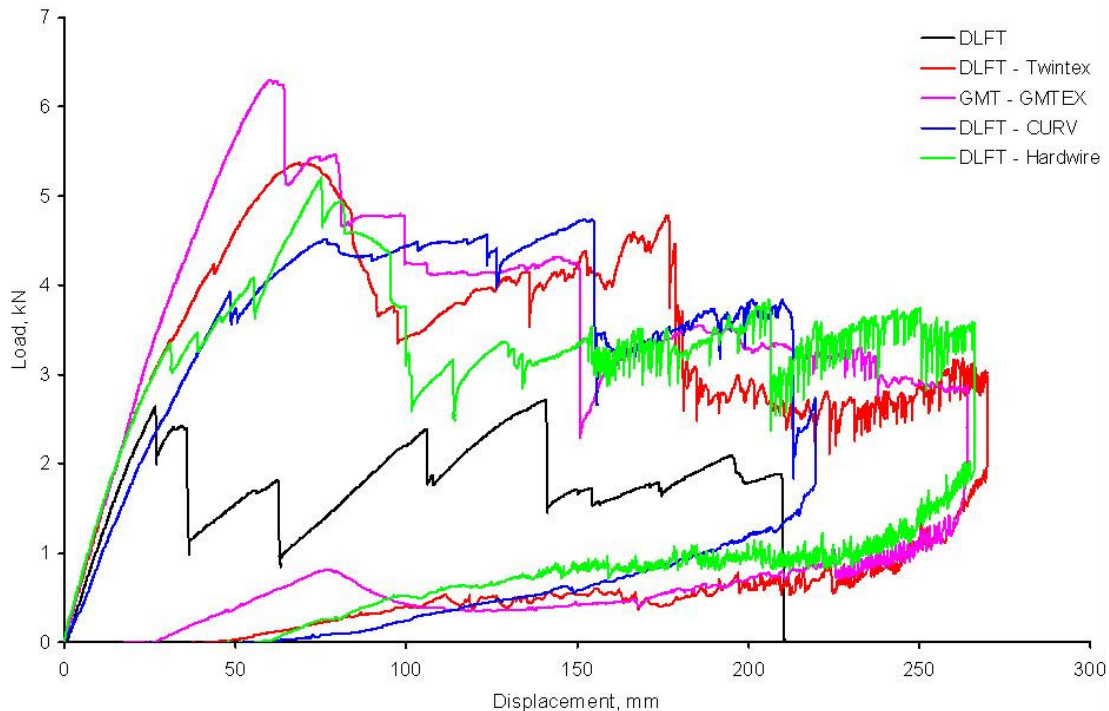
Figure 19. Load displacement curves for the five different inner panels tested.

The load-displacement curves for the composite inner panels are shown in Figure 19. The unreinforced “DLFT” panel shows a typical response for a chopped fiber panel with reasonable initial stiffness but a brittle response with failure at 20-25 mm and minimal load carrying capability

after initial fracture. The “DLFT – CURV” panel had both the lowest initial stiffness and the lowest peak force. This is not surprising given that half of the material in the latch box area was replaced with the unfilled CURV material. While CURV is not as stiff as the glass filled polypropylene that it displaced, its ductility allows the material to stop cracks and improve the system ductility. The “DLFT - Twintex”, “DLFT - Hardwire” and “GMT - GMTEX” panels all had very similar initial stiffness. The Hardwire reinforced panel started to crack at a load very similar to the unreinforced systems, but the reinforcement stopped the crack propagation and allowed the panel to reach almost 5kN maximum load. The Twintex and GMTEX reinforced panels had very similar properties with the GMTEX panel having the highest ultimate strength. The response of these reinforced panels was extremely encouraging and might contribute to the ductility response and resulting crash performance of the entire liftgate.
