DAMAGE REPAIR OF LOW VELOCITY IMPACTED WOVEN THERMOPLASTIC COMPOSITES

German Reyes^{1,2}, Uday Sharma³

University of Michigan-Dearborn, Dearborn MI, 48128.

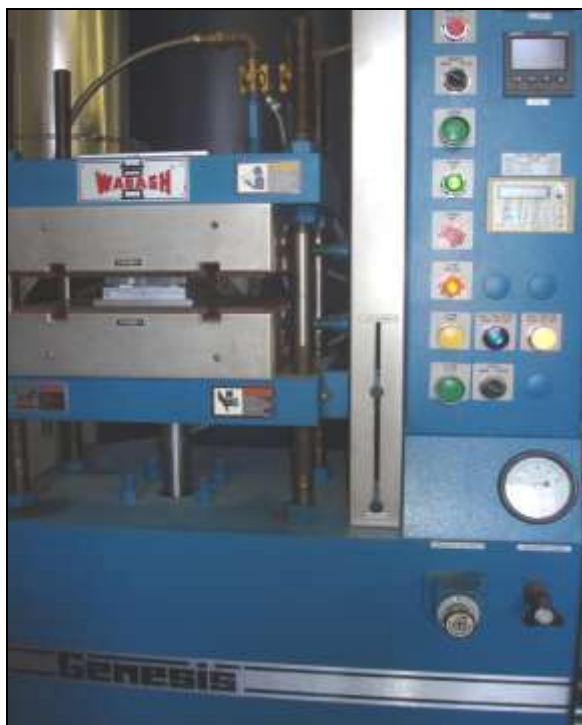
(a) Cold stamping press

Figure 1: (a) Cold stamping process in a cold press and (b) Instrumented dropping weight impact tower.

The composite panels tested in this research project were based on a woven glass fiber polypropylene with fiber content of approximately 60 % by weight. Twintex® PP-60, developed and patented by Vetrotex, is a prepreg made by the commingling of continuous glass filaments and PP filaments. Here, the commingling occurs during the glass fiberizing process, which guarantees a homogeneous distribution of two types of filament at an industrial price. Panels with dimensions of 240 x 200 mm were manufactured stacking three layers of the woven prepreg placed in a picture frame mold. The mold was then placed in an air circulating oven, heated to 180 °C and then removed for cold stamping in a cold press under a force of 4 tones (Figure 1a). Once the mold had cooled below 55°C, the panels were removed from the mold and visually inspected for defects. The manufactured panels were cut in to laminates with dimensions of 100 x 100 mm using circular cutting diamond wheel. The low velocity impact tests were conducted using an Instron Dynatup instrumented dropping weight impact tower shown in Figure 1b. Here, an impact carriage with 10 mm diameter hemispherical head was released from different heights to generate impact energies between 4 to 16 joules. The GFPP laminates were simply supported on a circular support and impacted at the center. During impact, the absorbed energy, Impact energy vs. time, load vs. displacement, velocity vs. time and impact energy vs. time histories were recorded using the Dynatup load cell, position, time and velocity sensors.

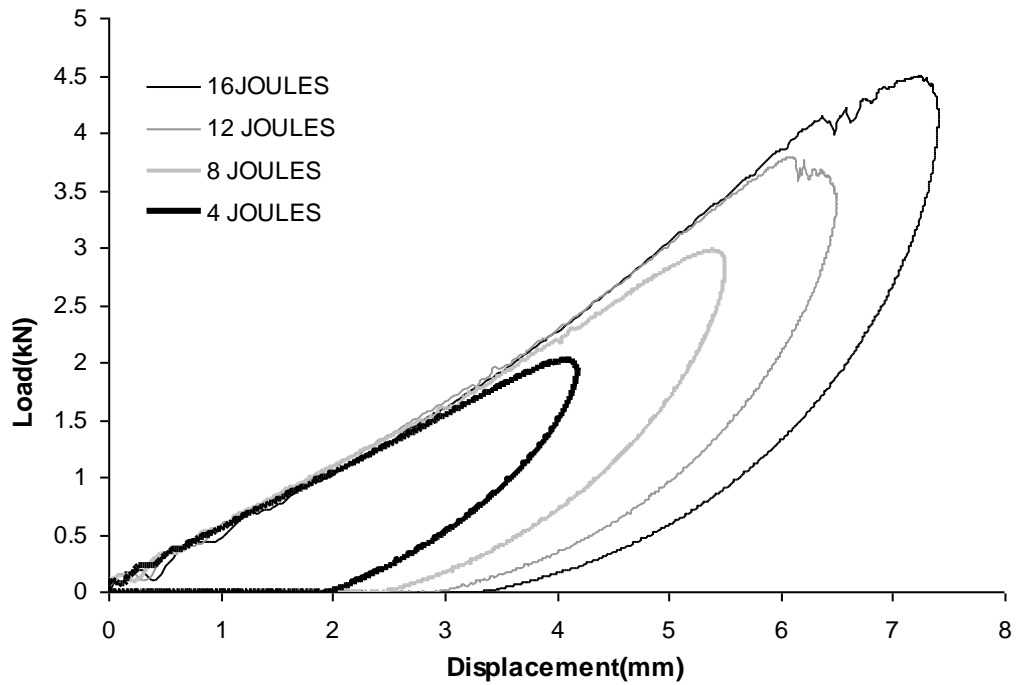
Figure 6: Typical load vs. displacement curves for the woven GFPP laminates subjected to impact between 4 and 16 joules.

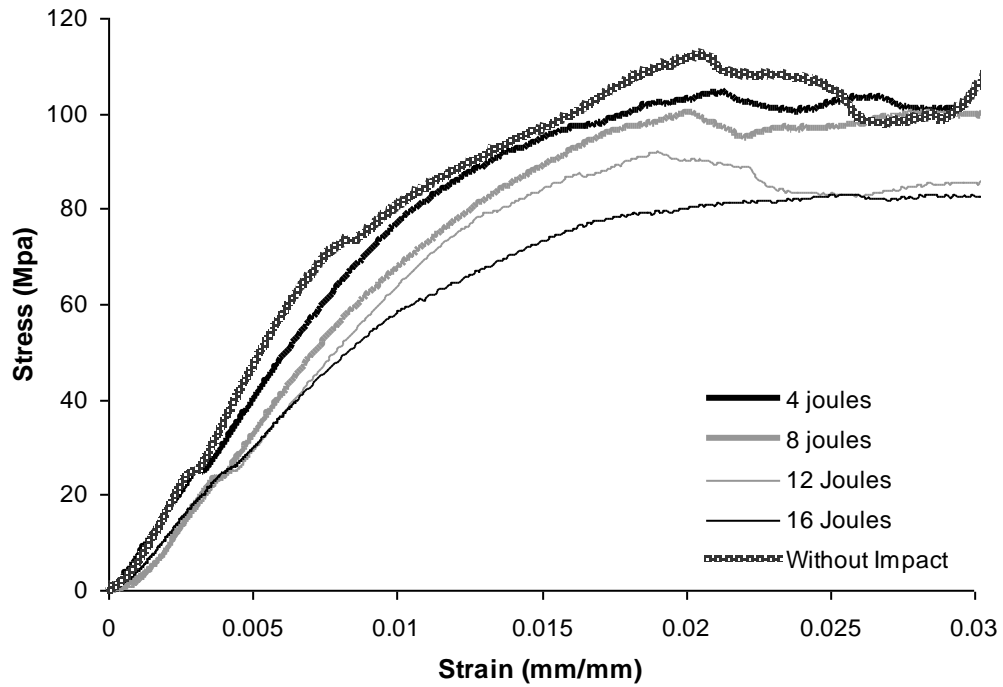
Figure 9: A typical stress vs. strain plot curves of impacted laminates under (4PB) loading conditions.

In order to evaluate the effect of low velocity impact on the woven composite, the low velocity impact damaged laminates were cut into 100 X 20 mm coupons and tested under 4PB loading conditions. At least four samples were tested for each impact energy. Figure 8 shows typical load vs. displacement curves of the impacted specimens under four point bending. Here, a reduction in specimen stiffness is apparent as the impact energy is increased. Furthermore, it is clear that the maximum after impact flexural load is also decreasing as the impact energy increases. In order to get a better understanding of the change in after impact flexural strength of the thermoplastic laminates, Figure 9 shows typical flexural stress vs. strain curves of thermoplastic laminates subjected to impact energies ranging from 4 to 16 Joules. Included in the figure is the behavior of the undamaged laminates. From the plot it is evident that the reduction in flexural strength after an impact of 16 joules energy is approximately 27 % and continues to decrease as the value of the impact energy increases. These results show that the reduction in flexural strength varies directly with the impact energy. Typical maximum values of flexural strength under impact energies of 4 to 16 Joules varied from 105 MPa to 85 MPa respectively.

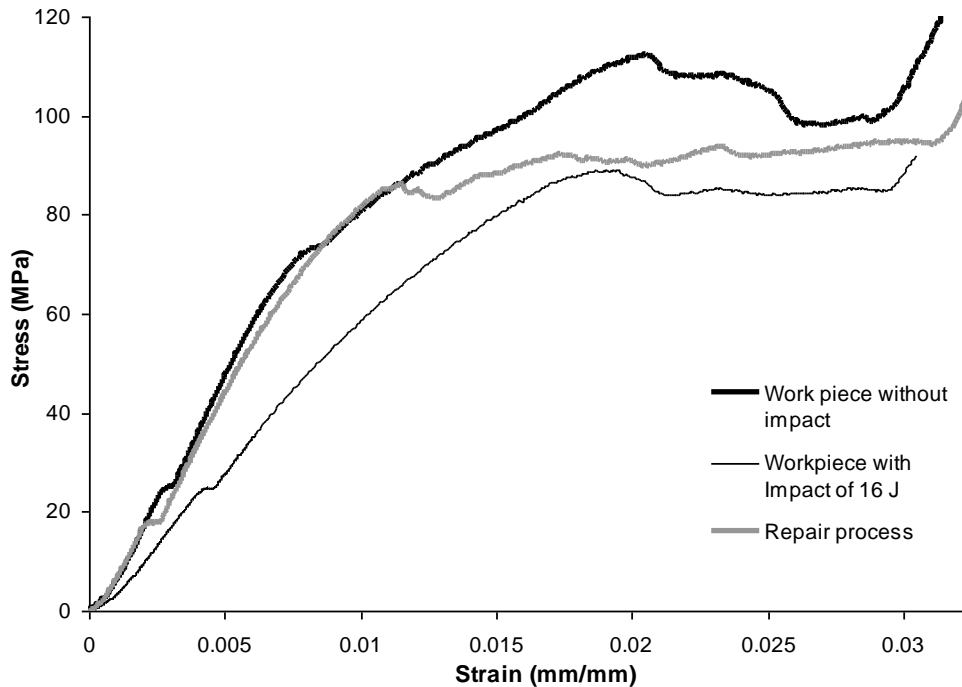
Figure 10: Stress vs. strain curves for woven laminates showing the effect of damage repair after impact.

Finally, in an attempt to revert the damage observed after low velocity impact, a simple compression molding damage repair process was applied to the 16 Joule impacted laminates. After this, samples of 100 X 20 mm were cut from the repaired laminates and subjected to 4PB loading conditions. Figure 10 shows typical stress vs. strain curves for the thermoplastic woven laminates without any damage, after a 16 joule impact and after the repair process was applied to the impacted specimen. From this figure it is clear that the initial slope, the associated stiffness and flexural strength have been recovered after the repair procedure. This result suggests that a simple one step process could be successfully used to repair impact damage thermoplastic woven composites.
