# No Postcure RRIM for Automotive Exteriors

Thomas A. Petrico  
Dr. Michael F. Hurley  
Bayer Corporation

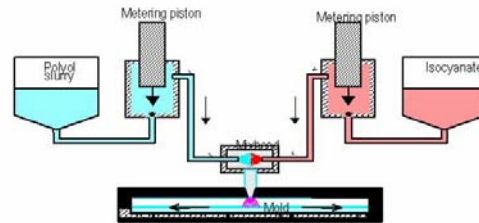
Figure 1. Simplified Schematic of the RIM Process.

Reaction Injection Molding (RIM) is a long established process for molding thermoset composites. It has been employed for automotive body panels and fascia for 25 years. In this process two liquid monomers, a polyisocyanate and a polyol or polyamine slurry containing filler, are metered at a controlled volume ratio. A simple schematic for this process is shown in Figure 1 below. These components mix and react as they flow into a closed mold.<sup>1</sup> Temperatures, pressures, and flow are carefully controlled.

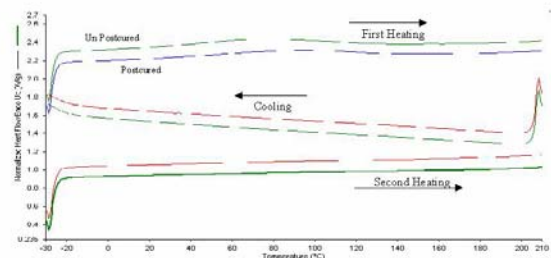
Figure 2 below shows the result of differential scanning calorimetry (DSC) performed on a sample of Bayflex 190 with 20% mica filler directly after molding and after 190°C cure for 45 minutes. The samples were scanned from -30°C to 210°C. The y-axis indicates heat flow. Each sample was scanned, cooled, and scanned a second time. Neither sample exhibited an exothermic peak (downward), which would indicate reaction of isocyanate. Both samples did exhibit a small, broad endothermic peak (upward). This is due to a small amount of water released from the mica filler. This peak is easily removed by warming to 100°C briefly.

Figure 2. DSC of Bayflex 190 Postcured and Un-Postcured

This data reveals no further detectable chemical reaction in the sample when heated up to 200°C. Were unreacted isocyanate present, an exothermic peak (downward) would be evident between 150°C and 200°C. In this region isocyanates react to form carbodiimide and isocyanurates. Nor does there seem to be any exothermic peaks for any other reaction under 200°C.

This data suggests that the Bayflex190 is virtually cured at demold since no exothermic peaks are evident.  
THERMAL GRAVIMETRIC ANALYSIS

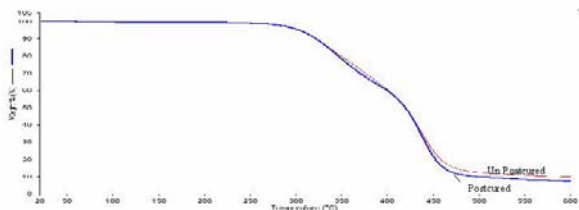
Gravimetric analysis is useful to determine weight loss of a material during heating. Release of gas would indicate evolution of CO<sub>2</sub> from isocyanate reaction. Figure 3 shows the weight loss for samples of Bayflex 190 with 20% mica reinforcement from 0 to 600°C. The trace for the un-postcured and postcured samples are nearly identical. Only the loss of 0.3% moisture, coincidental to the DSC above, is found between 50 and 100°C. No weight loss is found between 150 and 200°C where unreacted isocyanate would generate CO<sub>2</sub>. Small differences in weight loss are seen above 300°C, but these are well into the decomposition of the material. Thus there is no weight loss ascribed to isocyanate reactions up to 200°C for either postcured or un-postcured Bayflex 190.

Figure 3. TGA of Bayflex 190 Postcured and Un-Postcured

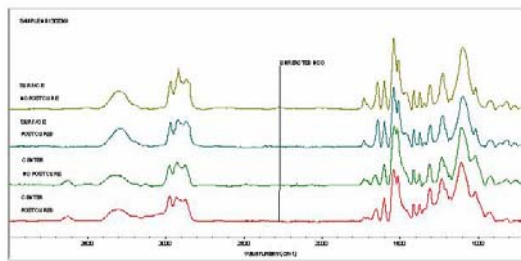
Analysis via infrared spectroscopy was carried out, in order to determine whether unreacted isocyanate were still present in parts after demold,. Normally the isocyanate group when present exhibits a very strong peak in the infrared absorbance spectrum near 2300 cm<sup>-1</sup>. Using FTIR each molded surface and the interior of a molded plaque were analyzed (Figure 4). Only very weak absorbencies were detected. It is known that other moieties containing functionality similar to isocyanate are found in this region such as carbodiimides. Such species are expected as existing already in the sample and account for a portion of the peak observed.

Figure 4. FTIR Spectrum of Bayflex 190 Postcured and Un-Postcured

Thus from FTIR analysis there remains little or no isocyanate present. Generation of CO<sub>2</sub> during paint processing is expected to be minimal. Paint defects due to out-gassing are not expected.

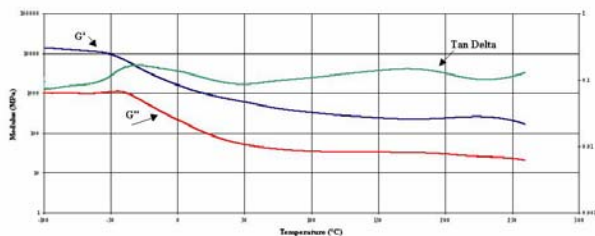
Dynamic mechanical analysis (DMA) was used to explain these inconsistencies. Figure 5 and 6 show the DMA trace of samples of Bayflex 190 with 20% mica reinforcement un-postcured and postcured, respectively. Shown for each sample are three traces – the storage modulus (G'), the loss modulus (G''), and their ratio Tan δ.

Both curves show a glassy state below -50°C and a broad rubbery region from 0°C to 200°C. No melt transition is seen beyond 200°C because the material is a thermoset network. Thermoset materials such as Bayflex 190 are networks, which upon heating above 250°C decompose rather than melt.

Figure 5. DMA of Bayflex 190 Un-Postcured

These data are nearly identical for un-postcured and postcured samples. Postcured samples show a slight increase in modulus below  $-50^{\circ}\text{C}$  and a small increase in modulus between  $100^{\circ}\text{C}$  and  $200^{\circ}\text{C}$ . This is consistent with a re-ordering of hard and soft segments within the polymer. After high temperature treatment the hard and soft segment separate further into more defined domains. This causes a more crystalline state at low temperature and thus higher modulus below  $-50^{\circ}\text{C}$ . There is also a slight flattening in the rubbery region consistent with improvements to impact values shown in Table 1. This is supported by comparison of the  $\text{Tan } \delta$  curve for each sample. After postcure the  $\text{Tan } \delta$  shifts its low temperature peak at about  $-50^{\circ}\text{C}$  to lower temperature. A broad peak near  $200^{\circ}\text{C}$  shifts to higher temperature.

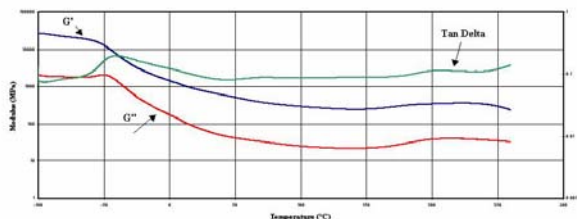
Figure 6. DMA of Bayflex 190 Postcured
